Macleay River Arm
Bank Rehabilitation Plan
Stuarts Point Caravan Park Foreshore

Prepared by Kempsey Shire Council
April 2009

The *Macleay River Arm Rehabilitation Management Plan – Stuarts Point Caravan Park* was developed for the purpose of addressing and managing erosion issues within the foreshore area. The objective of the Rehabilitation Plan is to provide a program of works and measures that identify the underlying causes of bank erosion, instability and implement strategies to address and remediate.

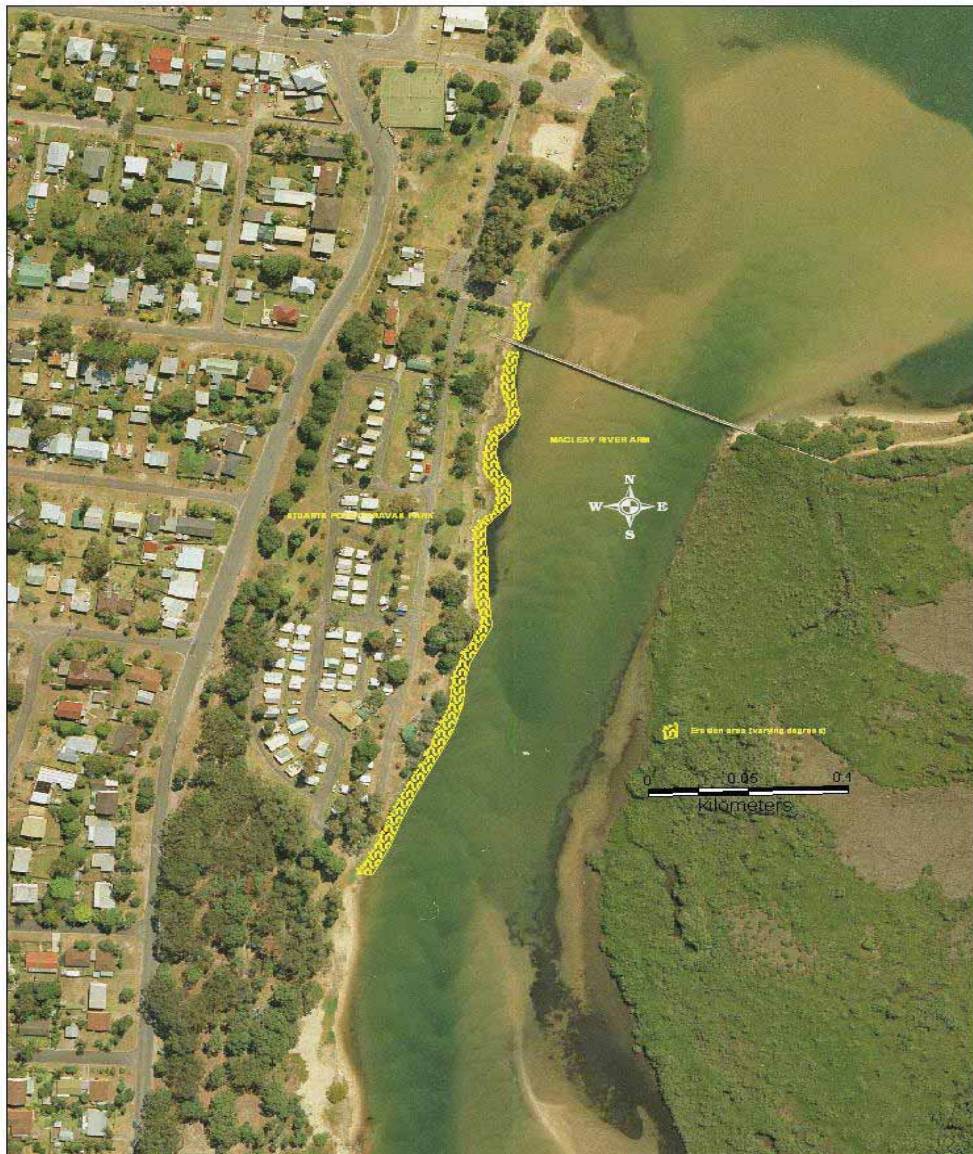
Figure 3 Image of Stuarts Point Caravan park and erosion areas

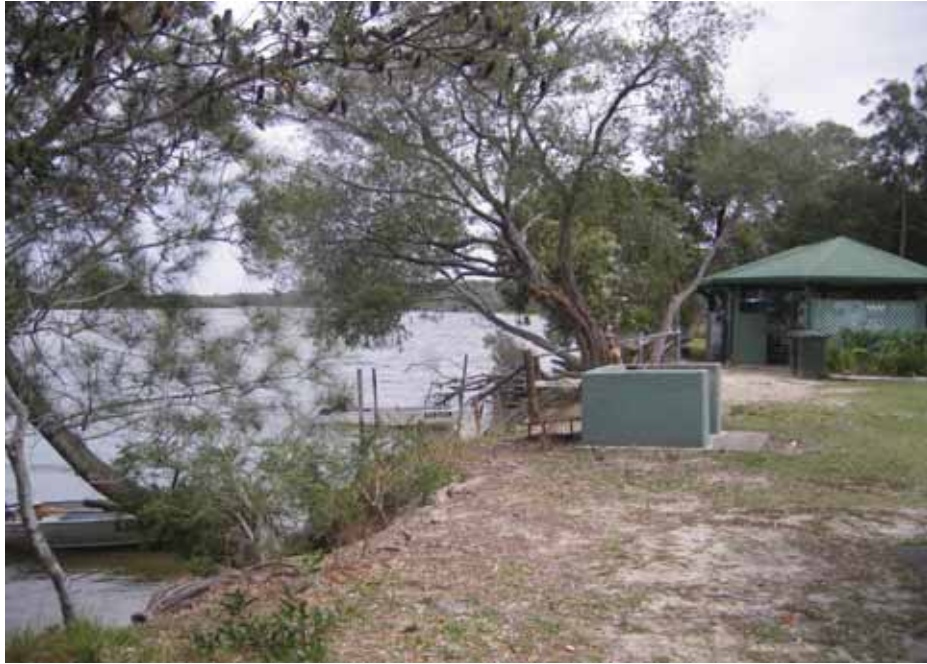
Figure 4 Public infrastructure under threat from bank erosion

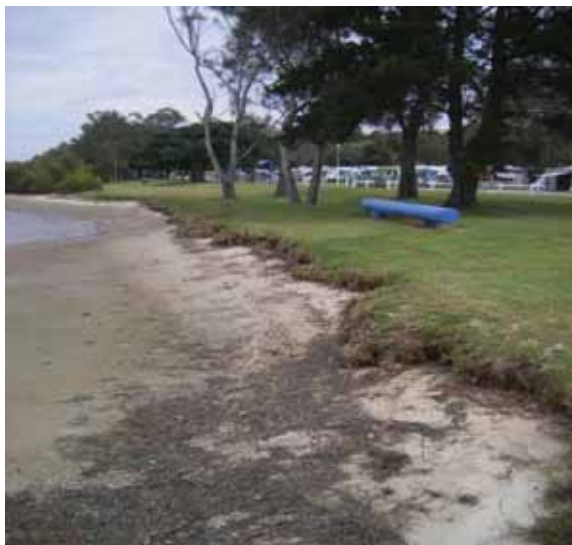
The river bank area of the Stuarts Point Caravan Park are composed of an erodible alluvium that when exposed and unprotected erodes (GHD 2005). The river bank form varies from banks heights (at low tide) of around 0.3m, a flat beach gradient (Figure 5) to approx 1.8m (Figure 6)

Figure 5 Beach flat erosion

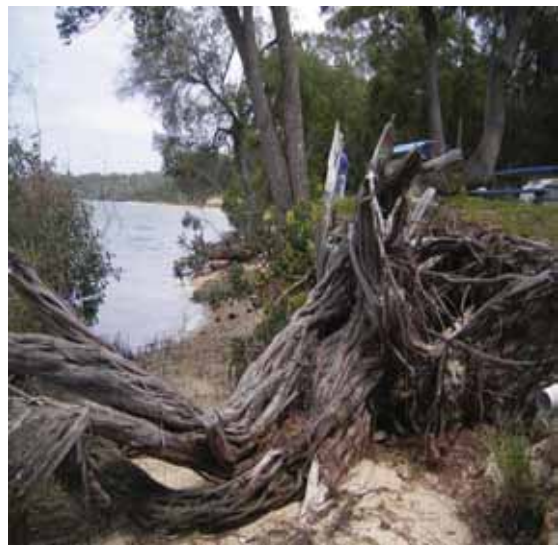
Figure 6 Steep bank erosion

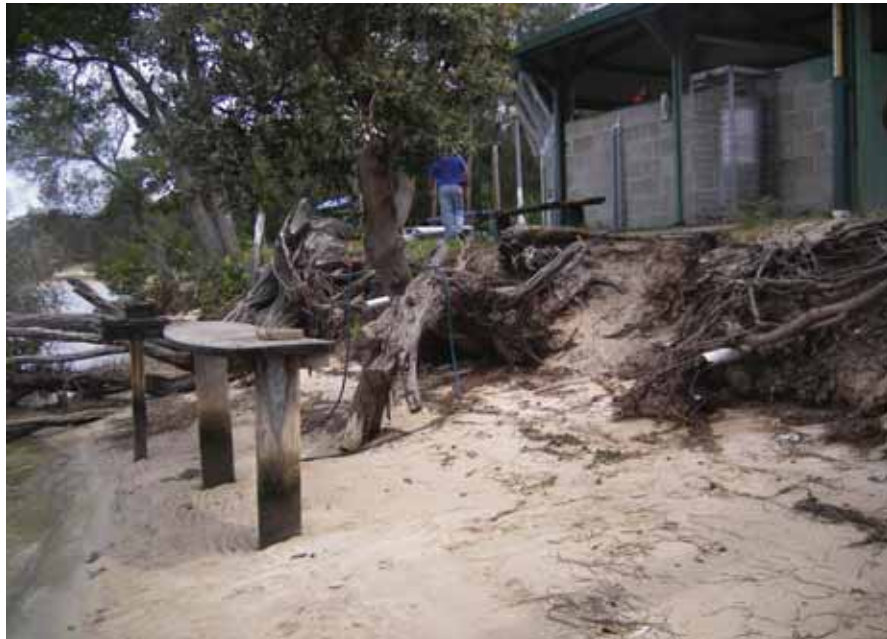
There are a number of surface scour locations within the Stuarts Point Caravan Park foreshore (Figure 7).

Figure 7 Showing surface scour resulting from pedestrian movement down the bank

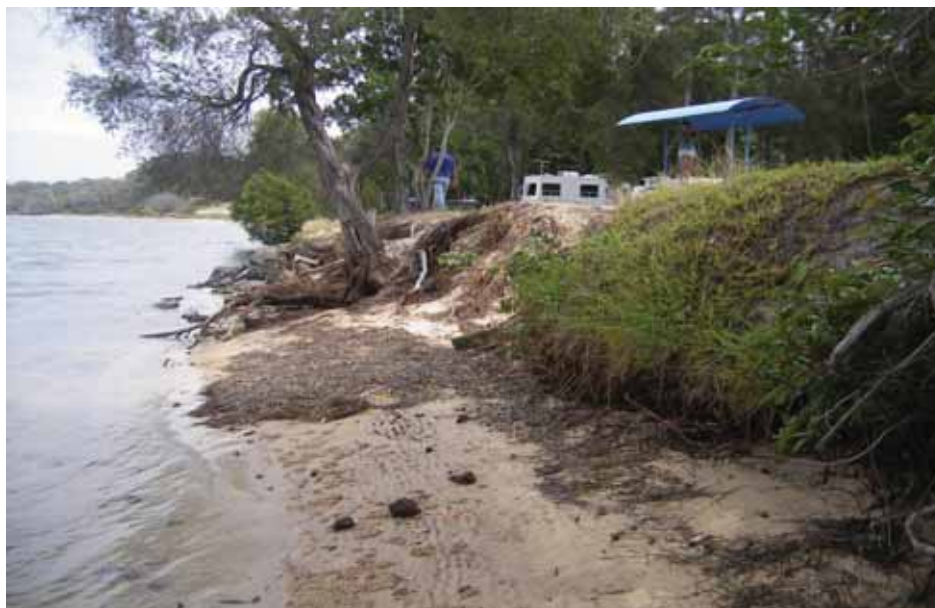
Along the Stuarts Point Caravan park foreshore there are a number of locations showing the visible symptoms of bank toe scouring.

Figure 8 Image showing toe scour erosion along foreshore

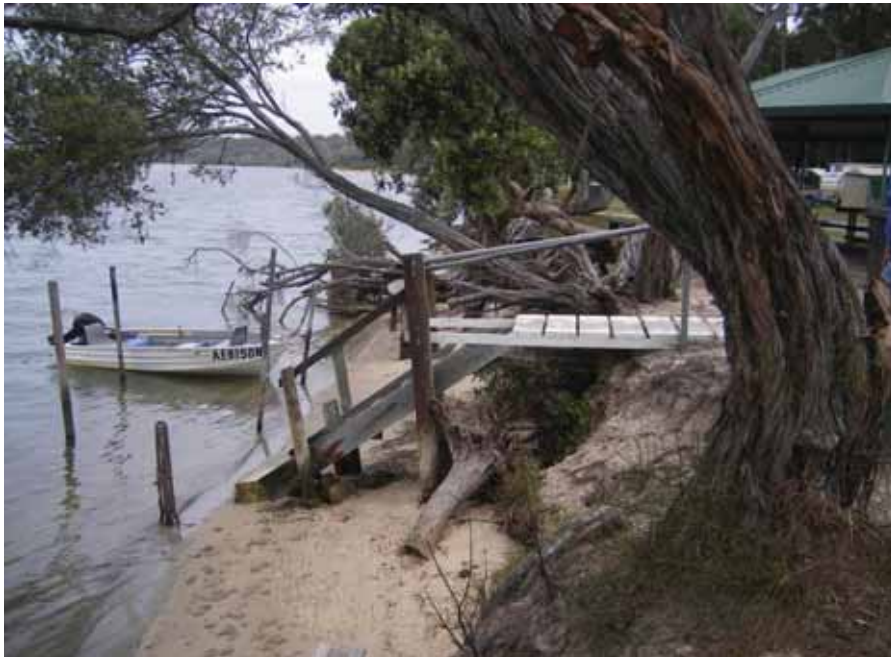
The GHD (2005) report indicated that this mechanism causing bank erosion is the primary cause of bank erosion along the Stuarts Point Caravan Park foreshore area.

Figure 9 Image showing wave induced erosion

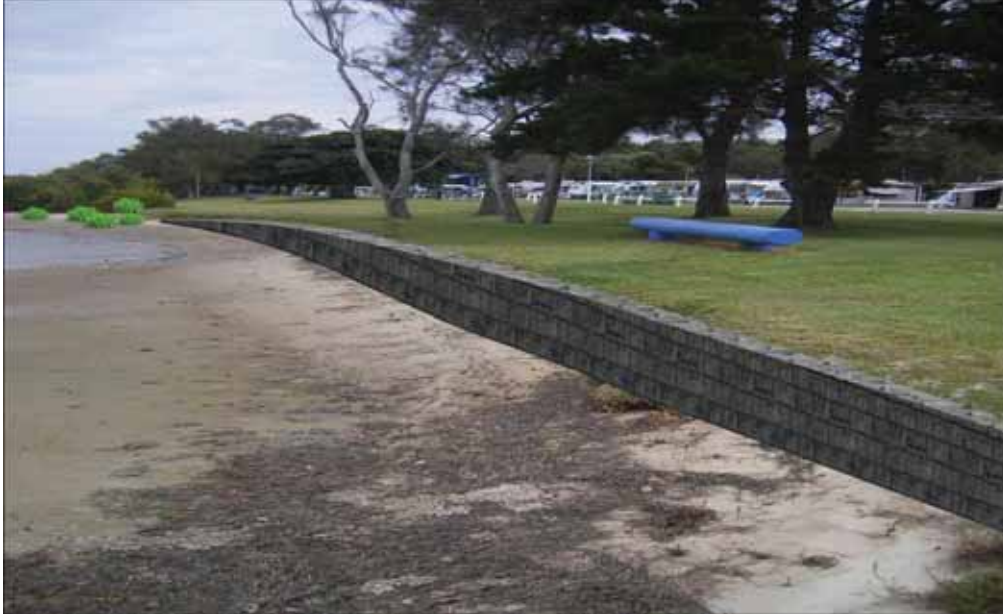
Figure 13. Proposed erosion remediation work – Zone 1

Given the bank geological characteristics and the high utilization of the area by both local and transient public, Options A & C have been identified as the two most preferred options to address and remediate the erosion areas of Zone 1 (refer Figures

13&14). Option A addresses the problem using a low level concrete block wall erected on a concrete footing. Option C requires the positioning of timber poles parallel to the bank. In regard to Option C, it is expected that in the near future the nearby pedestrian foot bridge will be replaced and as such timber from the old bridge could be utilised.

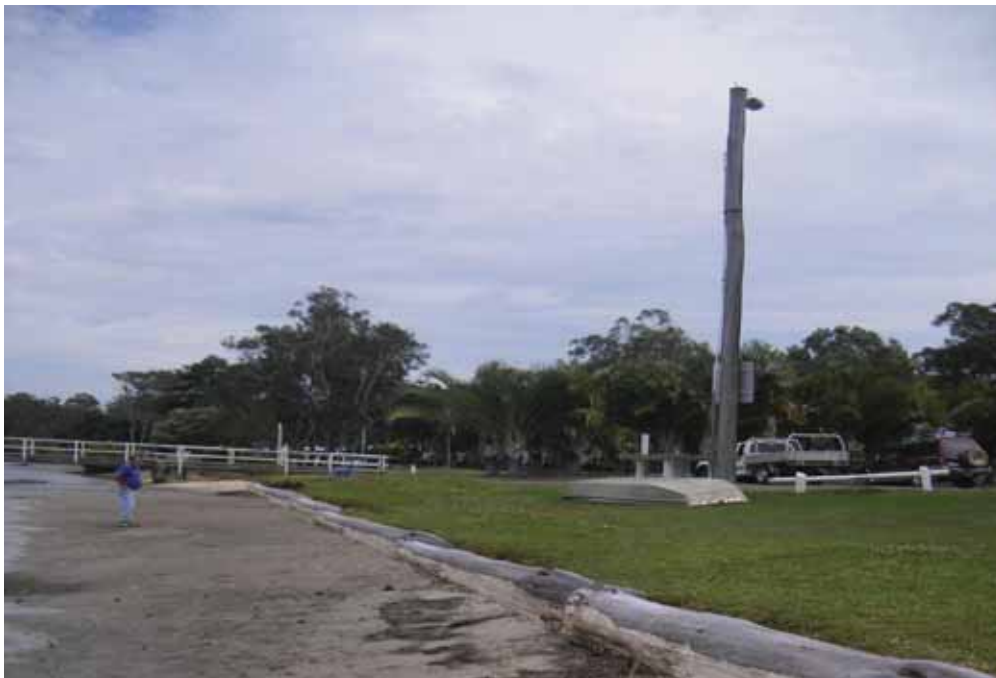
Figure 14. Proposed non-structural strategy for intact vegetation protection Zone 1.

It is a priority of this Rehabilitation Plan to ensure all intact native vegetation (Fig 15) remains and is protected from any possible future damage. To achieve this objective it is recommended that both Options D & E are implemented to ensure the integrity of the intact vegetation is sustained. They are;

To supplement the physical barriers, information/awareness signage is recommended to be erected, highlighting the importance of riparian vegetation.

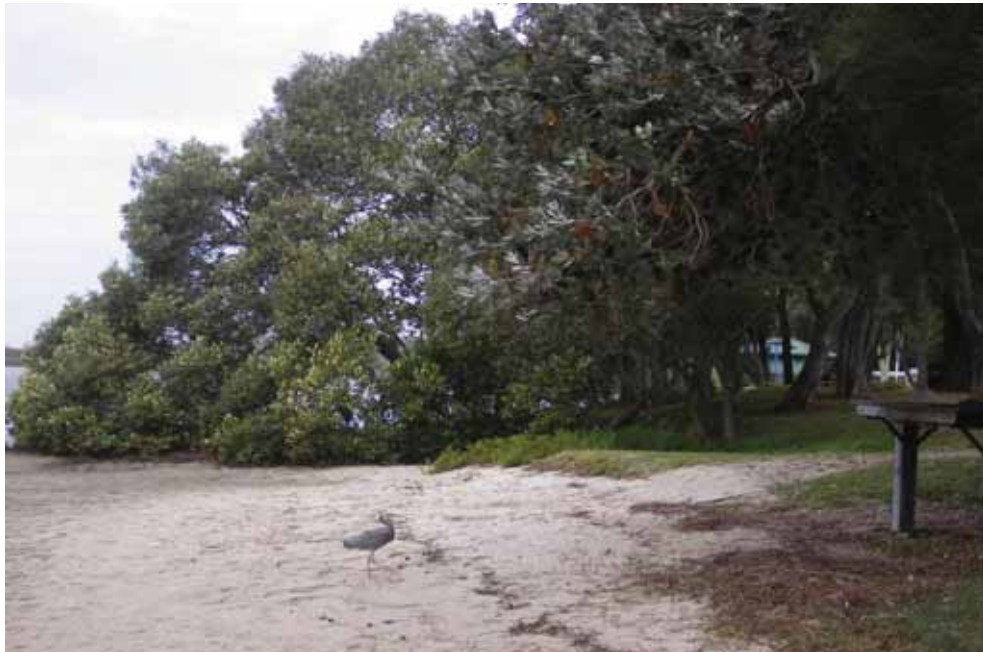
Figure 15. Intact riparian vegetation to be protected

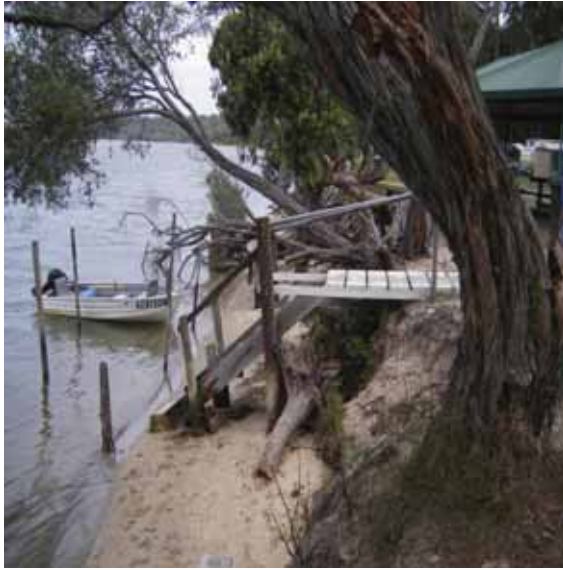
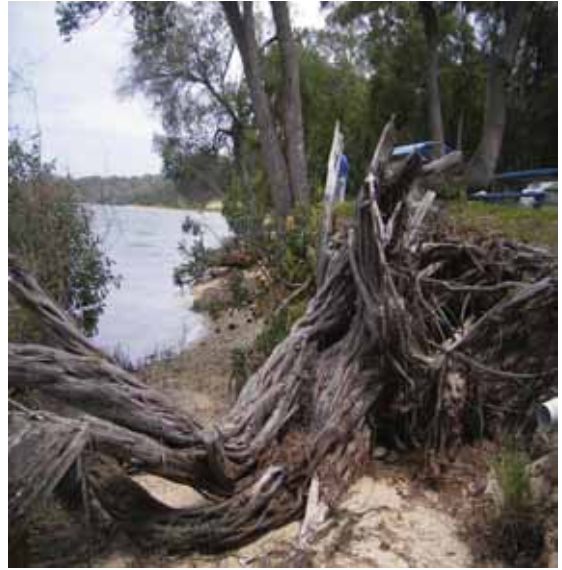
Figure 20 – Zone 3

Due to the steepness of the banks, level and severity of the current erosion condition of the bank, the immediate threat to park infrastructure and the high usage rate of the area for boating and fishing activates, it is recommended that a Gabion wall (Option F) be erected within area to abut the eroded bank.

In the situation where the proposed gabion wall may be damage or under threat from existing unstable large woody trees, such trees should be cut at the base, making all efforts not to disturb the root system. Where large woody trees are required to be felled, new suitable native species should be planted.

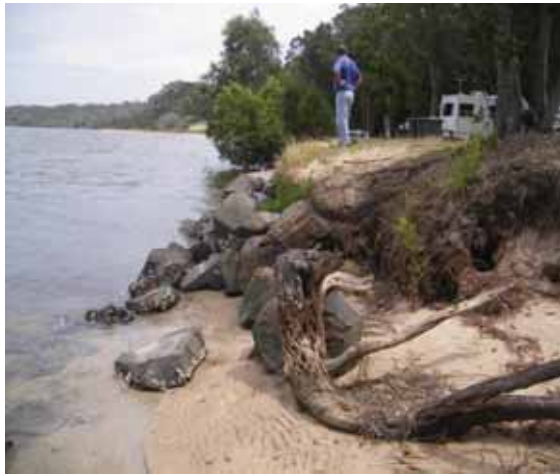
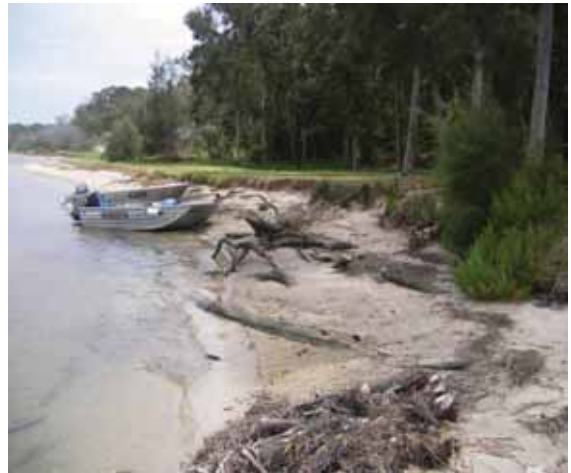
Figure 24 – Zone 4

In some locations within the northern section of Zone 4 large rocks have been positioned in the past to address erosion. This activity appears to have been successful in controlling erosion where the rocks have been placed. It is recommended that a similar strategy be undertaken within the entire length of Zone 4.

Based on the apparent successful outcomes from the previous erosion control measures, and the geological characteristic of the foreshore bank and the ability of heavy machinery to access the area, it is recommended that a low level (to bank height) rock wall (Option B) be considered for this area.

It is also recommended that boat launching and mooring in this area be discouraged.
