Consultants Report for Teal Lagoon, Boyter's Lane, Jerseyville NSW

2011

Prepared for Kempsey Shire Council

THE AUSTRALIAN NATIONAL UNIVERSITY

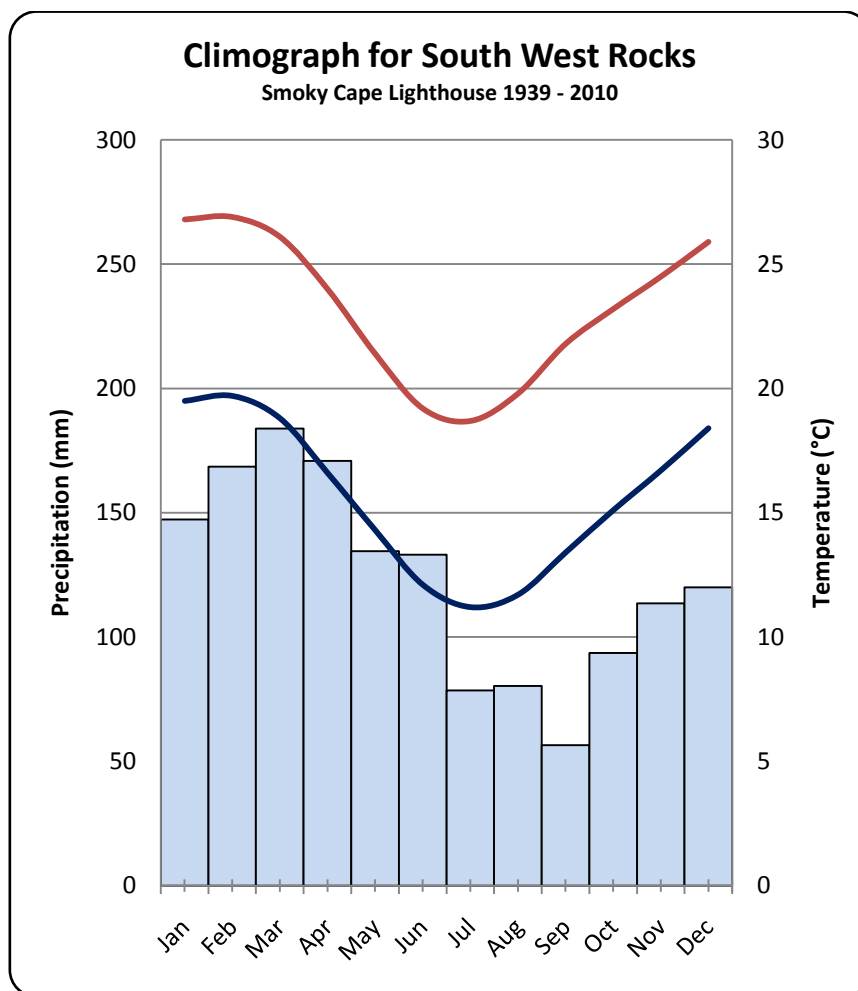
Figure 3 – Climograph for the study region (created from BOM 2011 data)

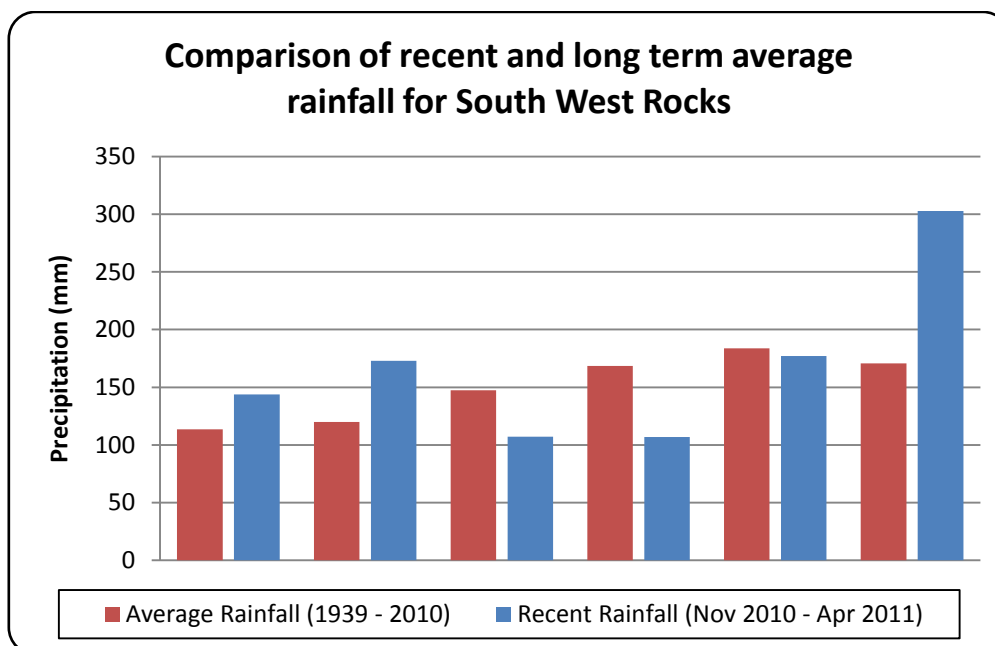
The region experienced above average rainfall for April 2011 during the period of study which can be seen in Figure 4 but there have been no significant climatic events in the region within the six months prior to the study being undertaken. The Macleay River was affected by flooding during May 2009, peaking at Kempsey at a height of seven metres on the 23rd of May 2009 (KSC 2011), but this is unlikely to have affected the results of the recent study.

Figure 4 – A comparison of long rainfall averages and recent rainfall for the six months prior to the study being undertaken (created from BOM 2011 data)

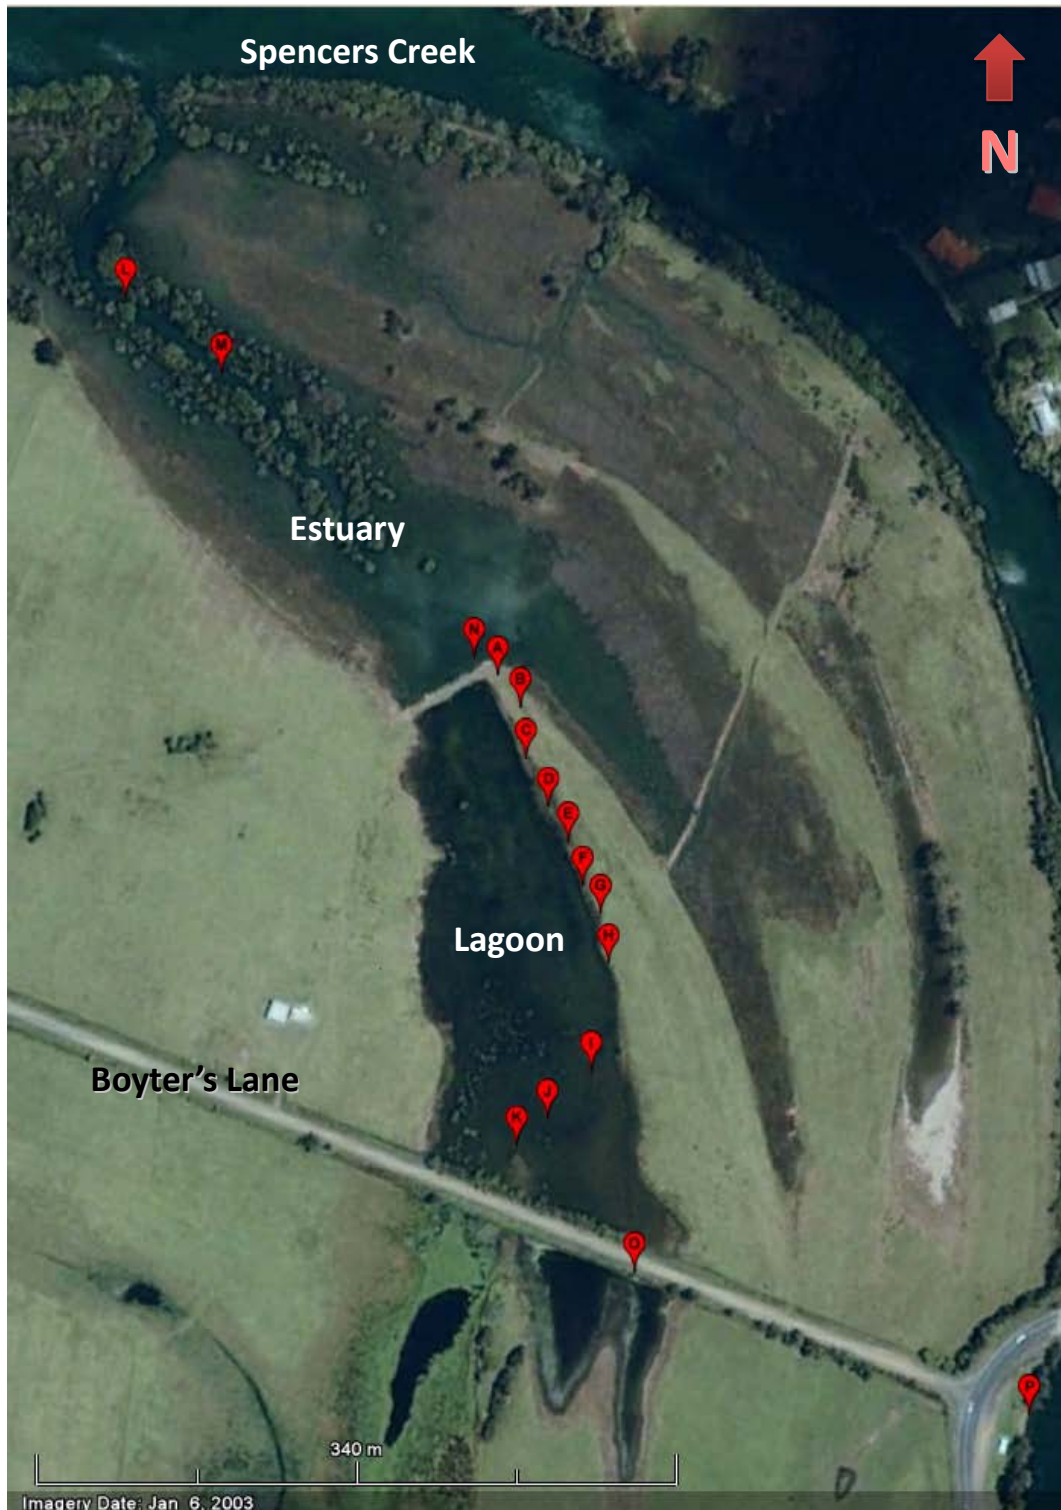
Water quality data was collected along a transect which spanned from the top of the lagoon closest to Boyter's Lane, across the berm and into the tidal creek at the opposite end of the site (see Figure 10).

Figure 10 - Teal Lagoon, transect marked out along the lagoon and berm

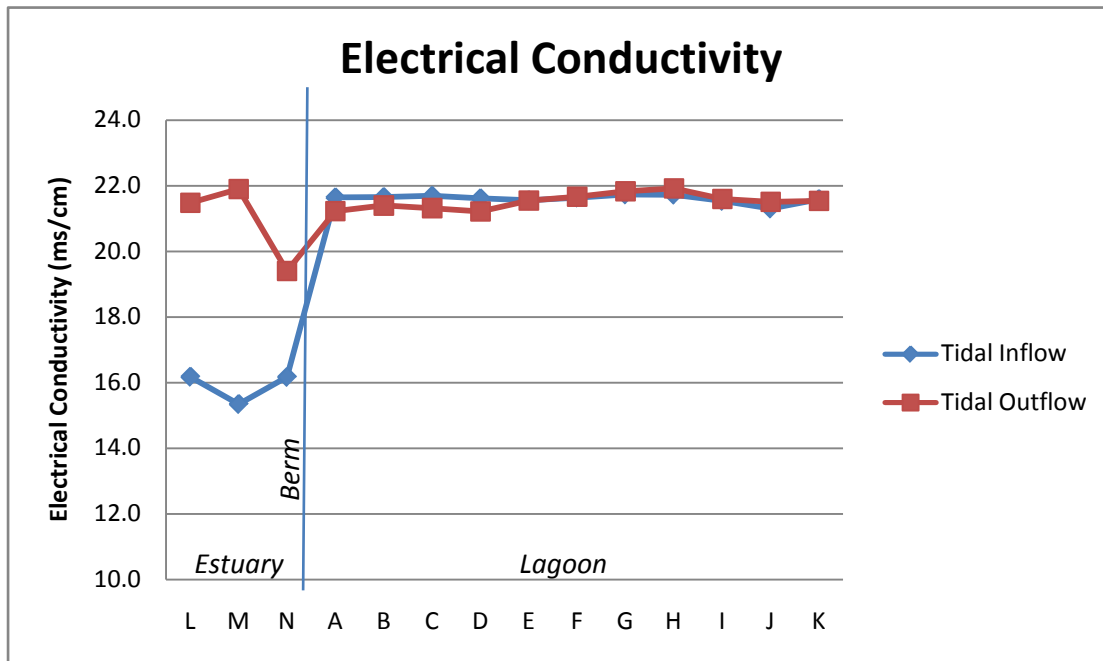
Figure 12 – Average electrical conductivity along the transect

Electrical conductivity is an indicator of salt concentrations in water samples (Geoscience Australia 2011). From Figure 12 it can be seen that the electrical conductivity in the lagoon has a uniform salinity of around 22ms/cm. This is slightly fresher than seawater but is right on the upper limit for healthy lowland systems according to the ANZECC guidelines (2000) which indicate EC should fall between 12.5 and 22ms/cm. The high salinity of the lagoon is most likely a result of evaporation concentrating salts within the permanent, shallow lagoon waters. Restricted outflow from the lagoon during low tide may also result in increased salinity in the water body as salt is continually pushed into the system by tidal activity but cannot escape out the estuary due to the placement of the berm.

There is a clear, significant leak from the berm during tidal outflow, as the salinity of the estuary water increases to match the out flowing water of the lagoon. The lower end of the berm is slightly influenced by tidal inflow as water is pushed in through the pipes and leaks in the berm; however the upper lagoon remains constant showing that tidal effects are not significant along the entire length of the system.

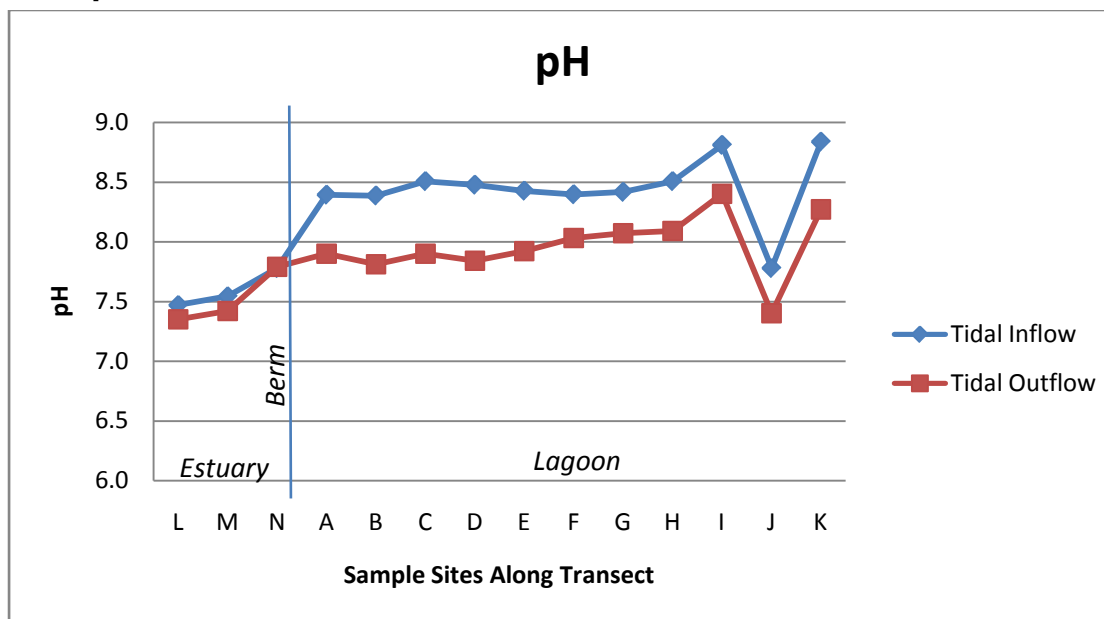
Figure 13 – Average pH along the transect

Figure 13 shows that over the length of the lagoon, there is a slightly increasing gradient in pH values, with the top of the lagoon slightly more alkaline than the waters close the berm. The increasing gradient is likely because pH increases as dissolved oxygen increases (Geoscience Australia 2011). Figure 11 shows that dissolved oxygen is increasing gradually and in a similar way to pH up the lagoon. Most of the values fall within 7 and 8.5 which is described as the healthy range for aquatic ecosystems by ANZECC (2000). Site I and K have slightly higher pH during an incoming tide but these are not considered to be significantly out of range. In terms of pH the lagoon system is functioning and healthy. It does not appear to be affected by Acid Sulphate Soils which are common in the region. The upper areas of the lagoon within the stagnant mangrove water is slightly alkaline. Flushing of the system would drop the pH to more favourable conditions.

The estuary waters are more acidic than the waters in the lagoon and the pH of water across the whole system is slightly higher during an incoming tide. This is again explained by dissolved oxygen increase as dissolved oxygen is higher within incoming tidal waters due to mixing with air as the water moves along Spencers creek and into the studied system. The drop in pH at Site J is likely to be a reflection of the sample location amongst the dense mangroves. The water in this region is stagnant and predominately dominated by rain water which is a possible reason to explain this anomaly. The decomposition of organic matter, which existed at site J, may also be releasing material into the water which is likely to be lowering its pH.
