Macleay River Arm
Bank Rehabilitation Plan
Stuarts Point Caravan Park Foreshore

Prepared by Kempsey Shire Council
April 2009

The *Macleay River Arm Rehabilitation Management Plan – Stuarts Point Caravan Park* was developed for the purpose of addressing and managing erosion issues within the foreshore area. The objective of the Rehabilitation Plan is to provide a program of works and measures that identify the underlying causes of bank erosion, instability and implement strategies to address and remediate.

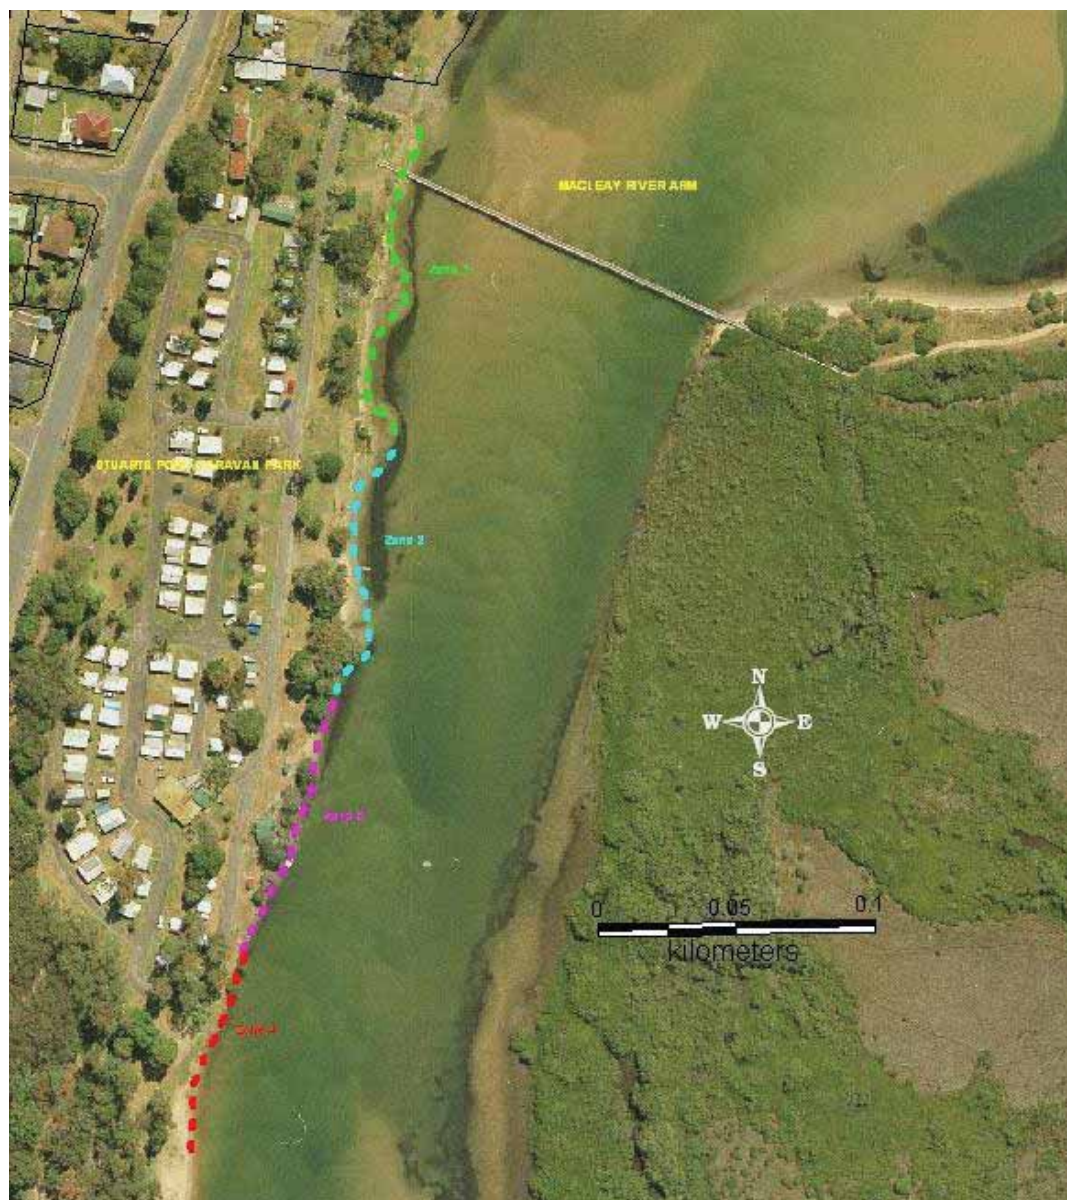
Figure 10. Erosion and remediation zones

The following image shows the Stuarts Point Caravan Park foreshore erosion and remediation zones. The zones have been identified and determined via site inspections, geological characteristics and assessment of possible erosion remediation strategies.

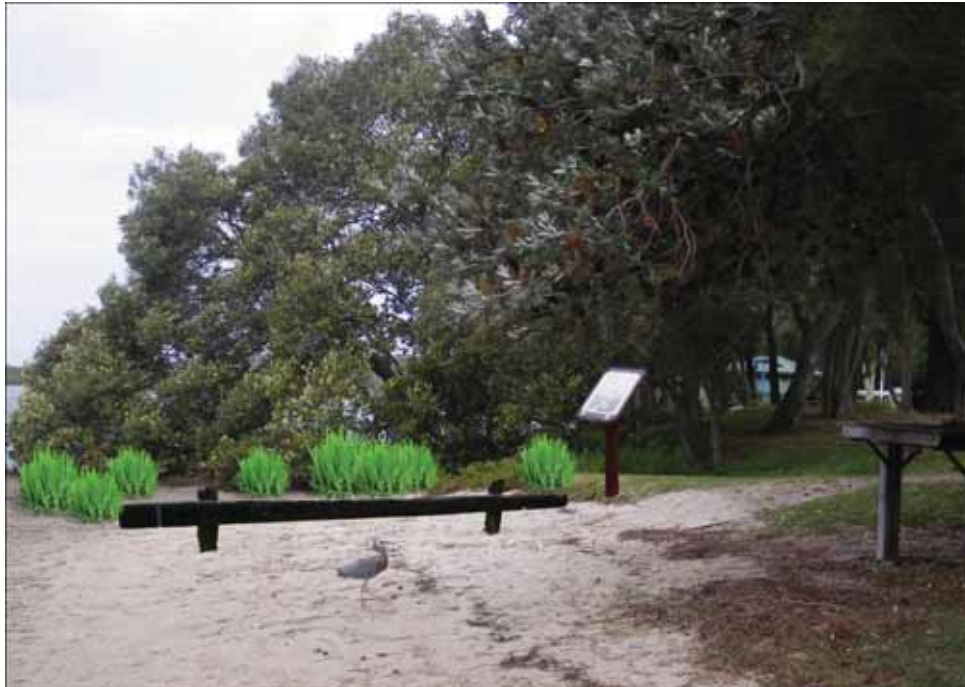
Figure 16. Intact riparian vegetation with signage and fencing

It is a priority of this Rehabilitation Plan to ensure all intact native vegetation (Fig 15) remains and is protected from any possible future damage. To achieve this objective it is recommended that both Options D & E are implemented to ensure the integrity of the intact vegetation is sustained. They are;

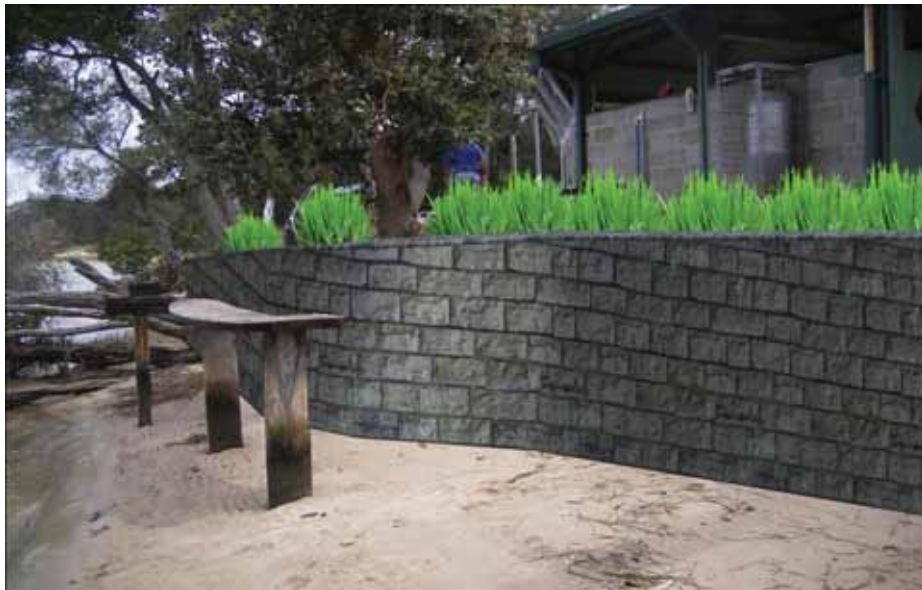
Figure 22 – Block Wall

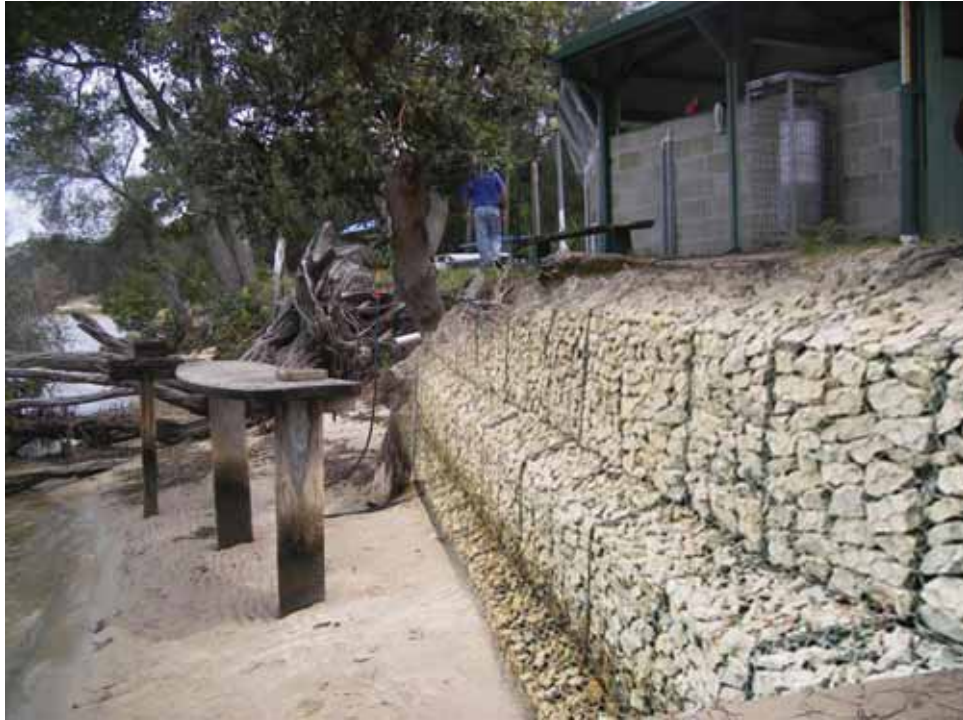
Figure 23 – Gabion Wall
