Memorandum

Subject: An assessment of potential radioactivity associated with the Crescent Head ilmenite stockpile

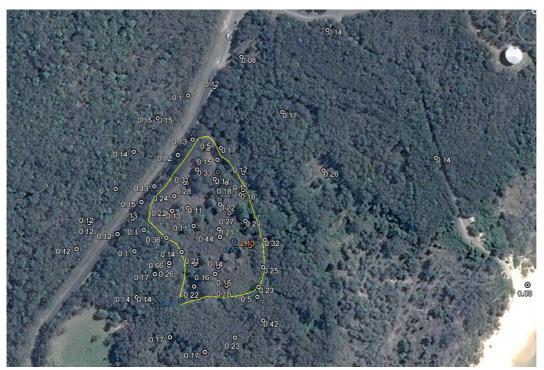
A field survey was been carried out by Pandanus Solutions in February 2018 using a RadEye B20-ER Survey Meter from ADM Nuclear Technologies. The instrument was calibrated prior to use. Readings were taken one meter above ground level on the stockpile, from off-stockpile (background), as well as from the nearby township of Crescent Head. Readings on the stockpile were taken on roughly 20m distances, with locations dependent on thickness of vegetation overgrowth. The survey results are summarised in Table 1 below, and illustrated in Figures 1 and 2. Results are tabulated in Appendix 1.

Figure 1. Overview of Crescent Head stockpile site and background field gamma readings (μ Sv/hour), with approximate stockpile outline shown in yellow.

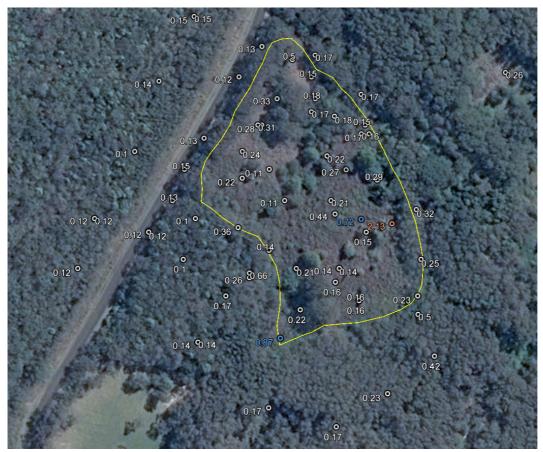
Figure 2. Detail view of Crescent Head ilmenite stockpile and background field gamma readings (μ Sv/hour), with approximate stockpile outline shown in yellow.

Additionally, because several point locations on the stockpile exhibit levels of gamma radiation that are significantly higher than the background values, the following approach is recommended during remediation of the site:

- 1. Point locations where gamma radiation levels are 0.72, 0.87 and 2.13 µSv/hour are signposted and dealt with in the first instance, by blending with low gamma level material to produce a gamma radiation level preferably no higher than 0.3 µSv/hour. If practicable, it is also recommended to deal with point locations showing 0.50, 0.50 and 0.66 µSv/hour at the same time and in the same manner.

- 2. A gamma radiation meter should be used to take regular readings from the stockpile during removal. If any elevated values are encountered the same blending approach should be adopted as in Point One above. A gamma radiation meter may be purchased or hired by GER and kept on-site during the remediation works for this purpose.

- 3. After all ilmenite has been removed but *prior to* placement of any topsoil or cover material, it is recommended that a second detailed gamma radiation survey be conducted. This survey is to be done to establish that all ilmenite material has been successfully removed, and to estimate the required thickness of topsoil cover required, in event any residual areas show elevated levels of gamma radiation.
